1st Level Facts & Features

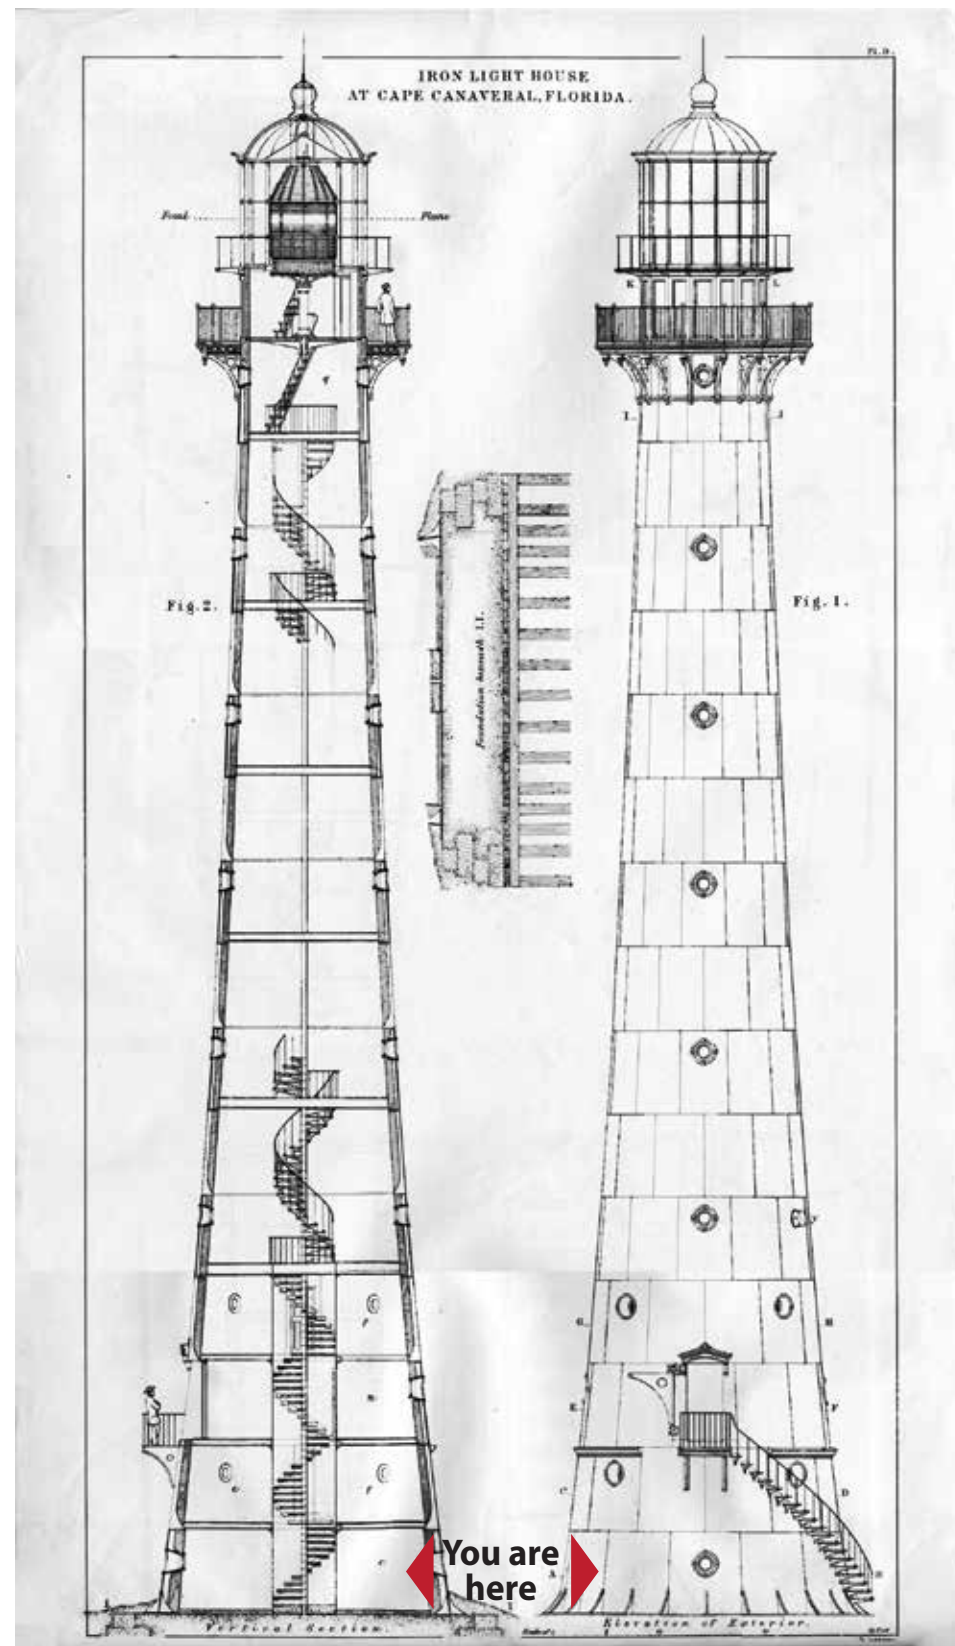
The entire lighthouse is made of cast iron. There is no steel.

The front door didn't exist until needed to install generators for electrification in 1931. The original entrance was via the outside stairs up to the 3rd level.

Two concrete pads on the floor to the right of the entrance held two generators used during early electrification before commercial electricity was available.

Radio beacon equipment was located on the west wall from 1931 to 1996. It was connected to an antenna constructed nearby. It sent out a Morse code signal (Z), unique to this lighthouse.

Water tanks on the 1st level stored rainwater collected by a gutter around the 2nd level – note the overflow pipe and the access pipe nearby.

There are 176 steps up to the light.

When going up the stairs, note the Roman numeral assembly numbers on the stair column. Each piece of the lighthouse is marked, for easy assembly.
