## 4th Level Right Room Facts & Features

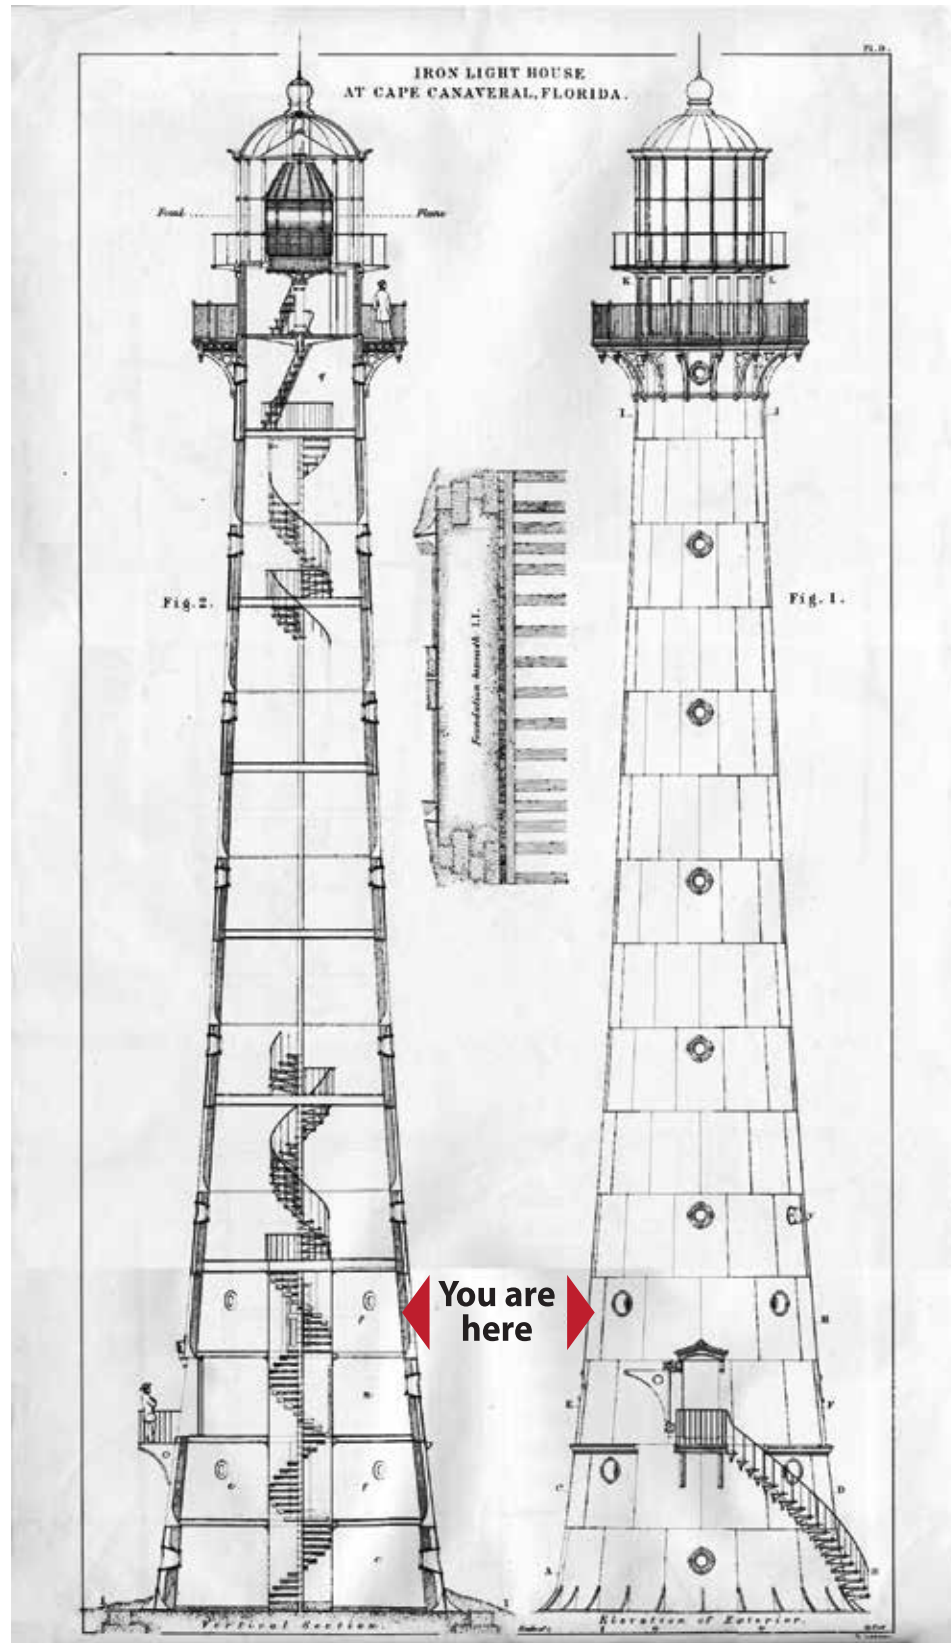
They were not sure in 1868 if the cast iron would be strong enough, so an inside brick layer was added. Insulation was an additional benefit.

The gray ring you see all the way around is a flange from outside plates locking into the brick layer, every 8 feet.

There is a 1½ inch gap between the brick and the iron.
